ENGINEERING PROJECTS:PROGRESS REPORT

Hurricane Matthew Recovery Project

Cross Creek Bank Stabilization at Lamon Street

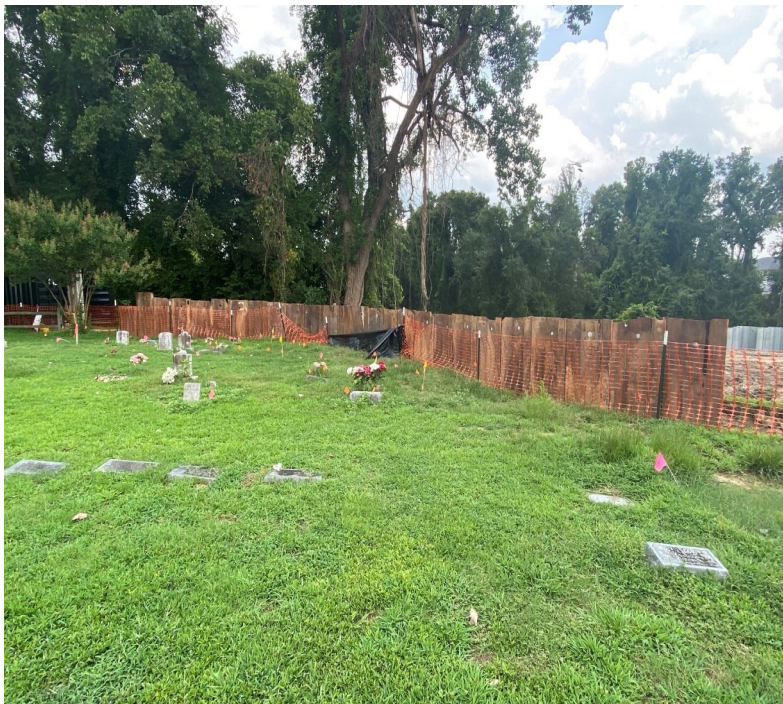
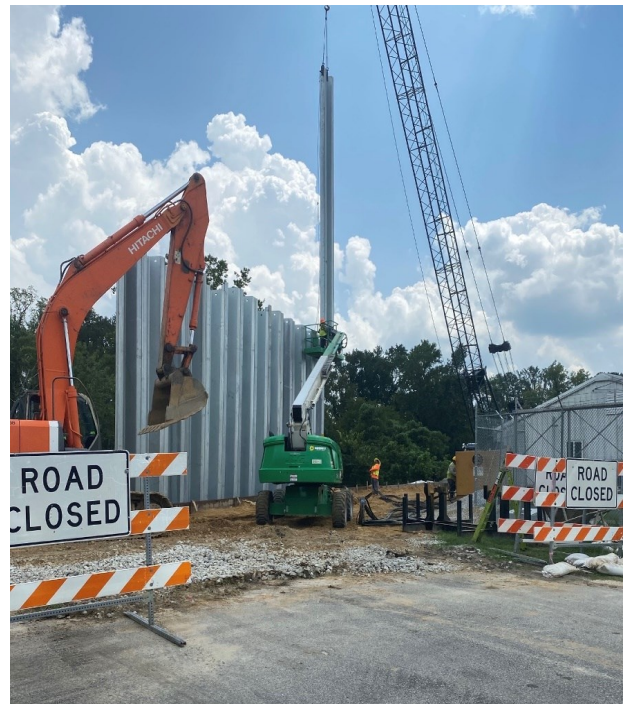
The contractor continued driving piles from Station 1+25 working towards Station 0+00. The contractor installed temporary sheeting. The contractor also conducted pre-activity discussions related to whaler and tie back system.
